WASH CLUSTER Situation Report

Sitrep 1

Type of disaster: Volcanic Ash fall

Location: Ambae, Penama Province

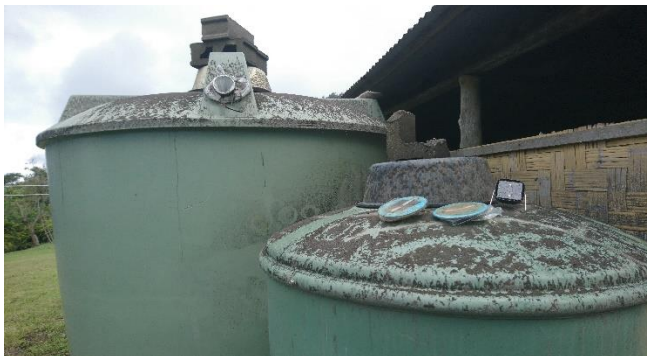
Water extraction point for water trucking is at Saratamata water system. Water trucking has started and is ongoing as the need for drinking water is eminent. It is still too risky for communities to reconnect their gutters. Rain comes down with ash causing many water sources like open well turning brown in color.

Gutters disconnected from tanks due to ash fall

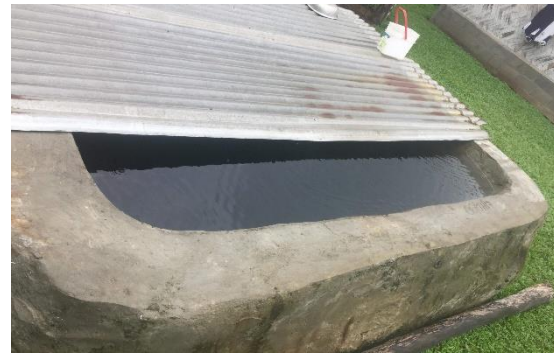
The situation in Ambae remains severe as heavy volcanic ash fall still posing big threat to the communities of Ambae. Vegetation in the Southern part of the island is completely dried up due to heavy ash fall. All water sources (ground wells and tanks are contaminated. Turbidity in the water is very high therefore unsafe for drinking and cooking. Acidity is generally low.

Water have turned brown in color

- ✓ Biological and Chemical Water analysis is highly recommended
- ✓ Needs proper full Water Quality Test Kit, (Physical, Biological and Chemical)
- ✓ Water Treatment(Chlorine)
